# City, Water, Life

## Achieving Water Circulation for Better Use of Urban Potential

# Ultimate Water Reforming Technology born out of the Nature of Japan

## THE BIOWATER Ω

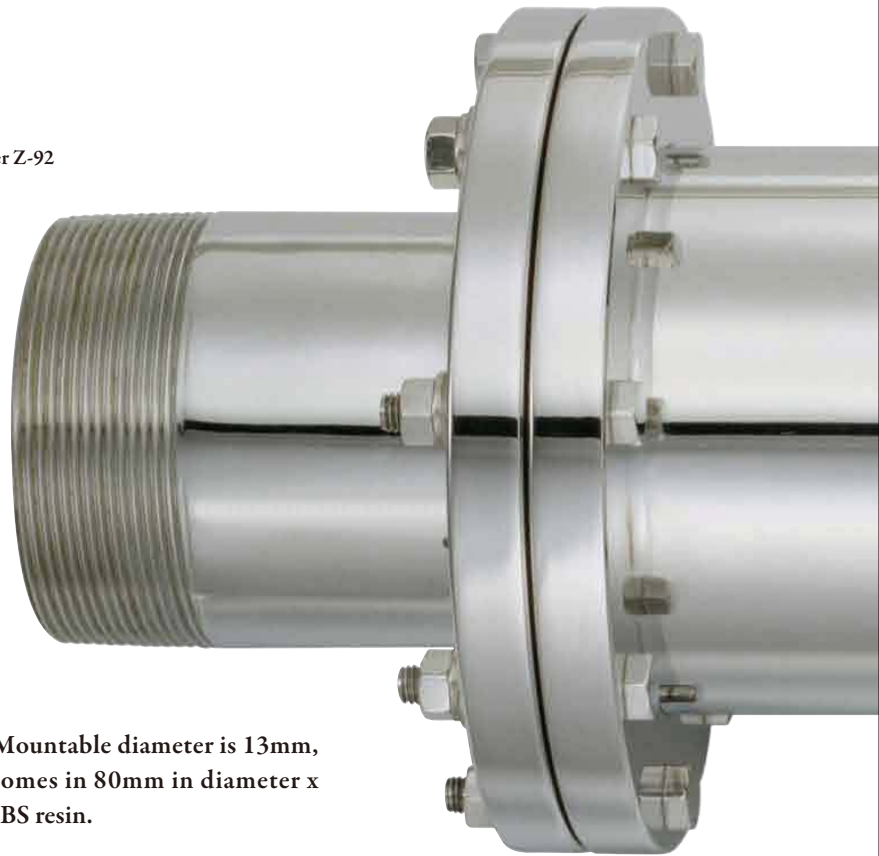
Mountable diameter of pipes ranges from 40mm to 125mm. Diameter size come from 190mm to 250mm and length is from 580mm to 1,100mm. Weight is from 10kg to 30kg. For more details, please refer to the specification sheet. Purchased material of SUS304 is common to all types.

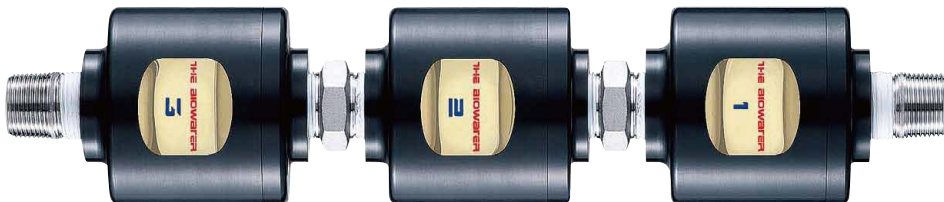
### BW•1-2-3

This water reforming device is for home and shop use. Mountable diameter is 13mm, 20mm, 25mm, and 32mm.(two items parallel.) Size comes in 80mm in diameter x 240mm.in length. Weight I 1.5kg. Exterior material is ABS resin.

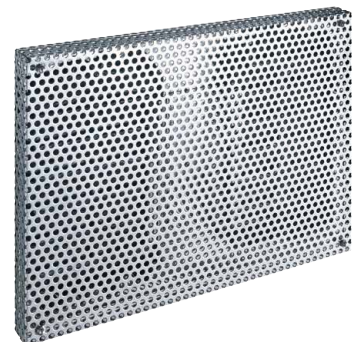
### BW Punch Box

This water reforming device is for use in water tanks. Depending on the size of the water tank and the water retaining time, you can adjust the number of sheets to be applied. Outside material is SUS304. Water reforming power is one cubic meter per four hours per sheet. Size is 340mm x 250mm x 30mm.

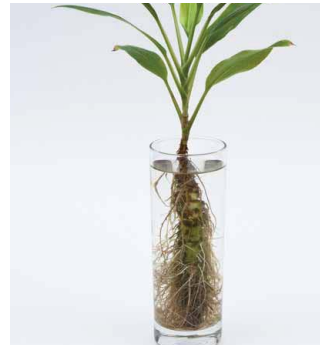
### Cut flower is robust again.

We put a bouquet of dracaena in BW reformed water, then roots started to grow from the cut stem in 2 months. After a year, the stem grew thick. After a year and a half, roots grew to the size nearly three times as large as the stem as the photo shows.

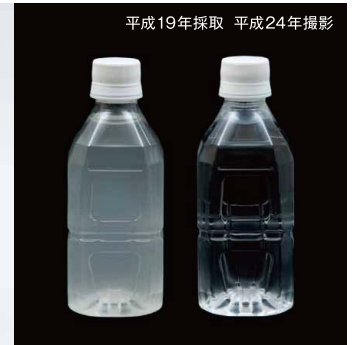
### Reforming power is maintained for 5 years.

(Water was filled in 2007, photo was taken in 2012.)  
The photograph shows the well water (hardness of 500ppm) used by Okinoerabu Jima China-cho Municipal Floral Hotel. Right bottle contains well water after flowing through THE BIOWATER and left bottle before flowing through BW. BW processed water is clear even after 5 years from intake. BW unprocessed water remained clear for 10 months but turned white thereafter.

Effect of water reforming is maintained for a long period. Laboratory test demonstrated an effective period of over 10 months. In the field test, it was confirmed to be effective after 5 years of use.  
[Please refer to the right photograph.]

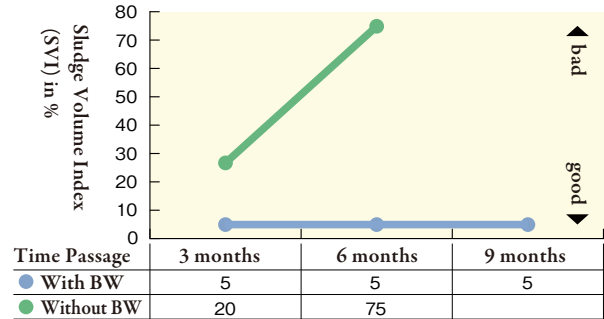
**[Proof 2] Sludge of septic tank was reduced significantly.**  
 superoxide, a kind of active oxygen was artificially created. Add reformed water to it and measured the reduction of superoxide by ESR (electron spin resonance) method.

This result was measured in the septic tank of Mr. N's residence in Odawara-city, Japan during 1999 ~ 2000. Chart was prepared from the data monitored by "Izumo" Suiji Kanri (Hydraulic Management) Center.

**Growth Rate of Sludge in 6 Months before installing BW**  
 ⇒ 375% (from 20 to 75 in SVI)

**Growth Rate of Sludge in 6 Months after installing BW**  
 ⇒ 0% (from 5 to 5 in SVI)

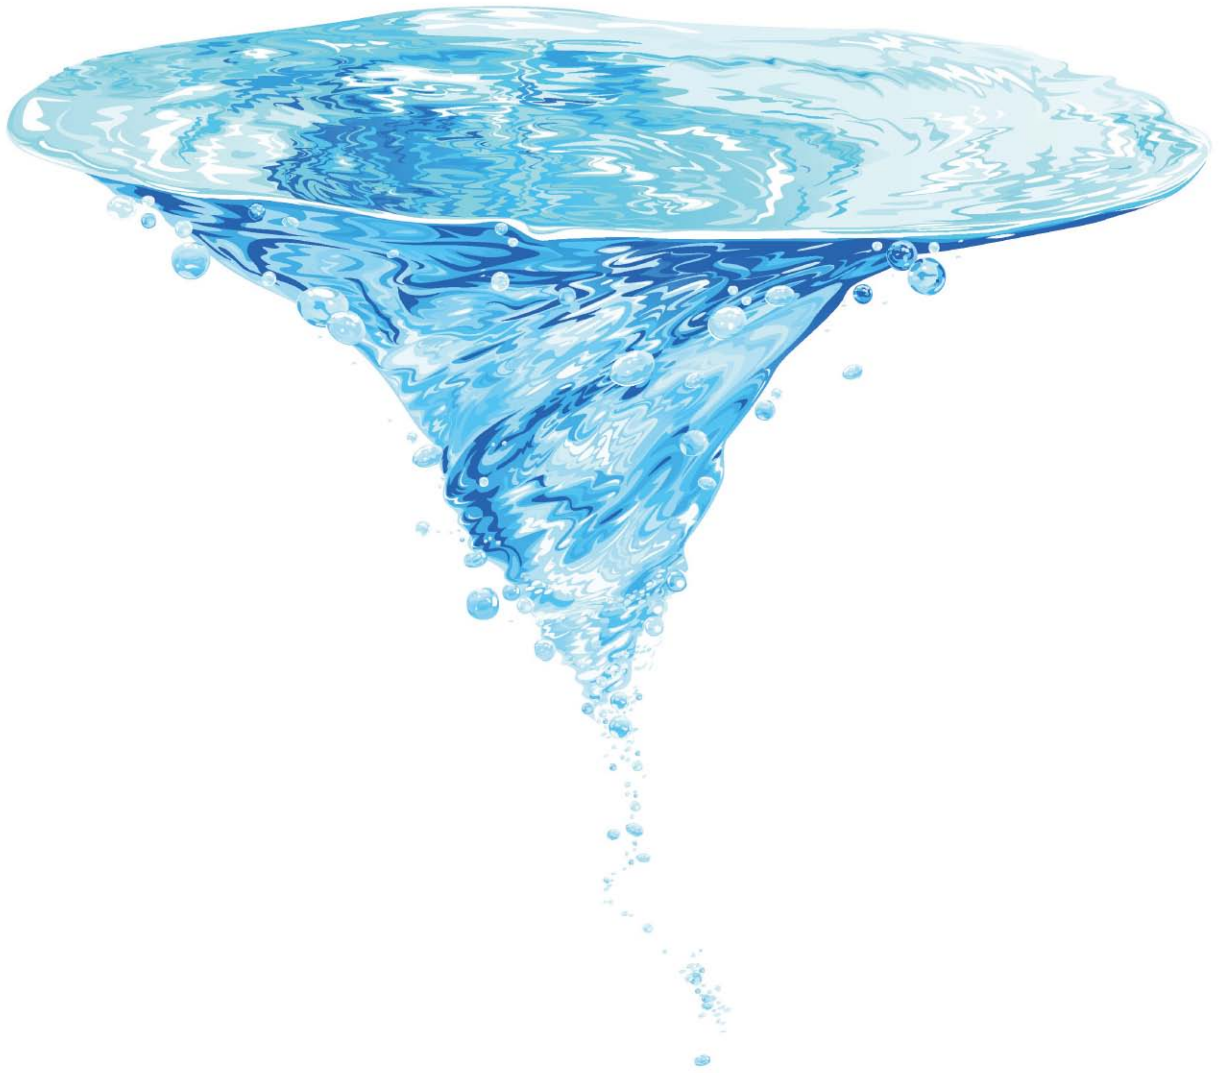
Mixed Water Test Piece Concavity and Convexity (BW processed)

Please find the three line graphs from our field test data from our funded research with Japan Railway (JR) Takasaki Station. We compared the roughness of the bare metal after scraping the corroded portions from the test piece. Test piece in which BW unprocessed water flowed had severe roughness while the test piece in which BW processed water flowed had smooth surface. In the comparison of corrosion mass per area of the test pieces, **BW processed water showed less than half the amount of that of BW unprocessed well water and less than one third of that of BW unprocessed tap water. This confirms the corrosion control effect of THE BIOWATER.**

Above data from the roughness gauge verifies that the test surface has a severe asperity for the tap water test piece and the corrosion waste exists on the entire test surface. In the case of well water, the roughness is seen although it is not as severe as in the case of tap water, showing corrosion waste on the entire surface of the test piece. On the other hand, in the case of BW mixed water, the degree of roughness is small. One can see a slow progress of corrosion on the entire test surface.

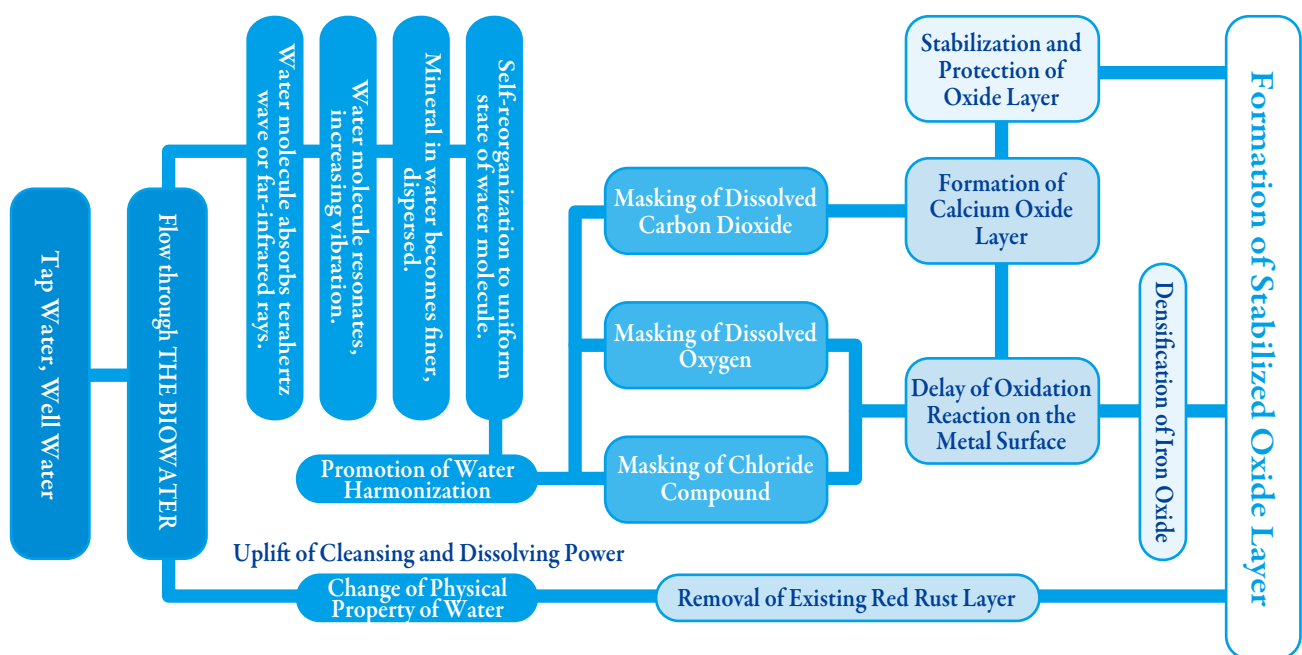
Inside the water reformed by THE BIOWATER, a special mechanism works where the process of oxidation takes place slowly as the chart demonstrates.

No iron corrodes in water. The issue here is what kind of rust is formed. Rapid oxidation produces red rust. Slow oxidation produces black rust. Black rust prevents red rust from forming. “Fight rust with rust!” is the main concept behind such products as “weather proof steel” or “COR-TEN Steel.” Our “Oxide Layer Method” is a technology applying the same concept to water supply pipes. Once black rust which is magnetite or ferrous-ferric oxide is produced, it forms a layer coating the inner surface of the pipe, halting the degradation of the pipework. Furthermore, there exists a special type of microorganism called “Iron Bacterium” , which is deeply involved in the formation of rust. What is great is that water reformed by THE BIOWATER restrain the generation of iron bacteria as well. As the chart shows, once we reform the water by THE BIOWATER, the physical feature of the water is changed in a way to start the process of “red rust peeling and removal while forming black rust” , protecting the pipework.

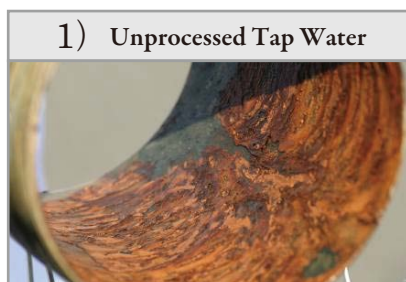
Corroded product covers the entire surface of the test piece. It is iron oxide with rough structure easy to peel off.

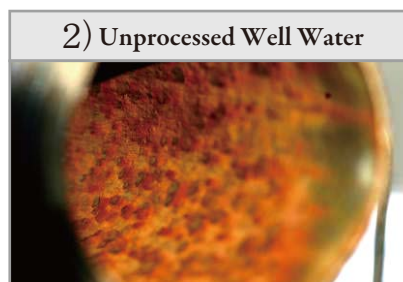
Corroded product is finer than that of unprocessed tap water, sticking tightly to bare metal. This corroded product covers the entire surface like that of unprocessed tap water.

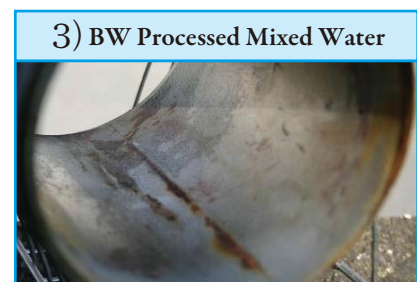
Electric resistance welded point has fine rust but other part has no corroded product. The situation is completely different from that of those two other cases.

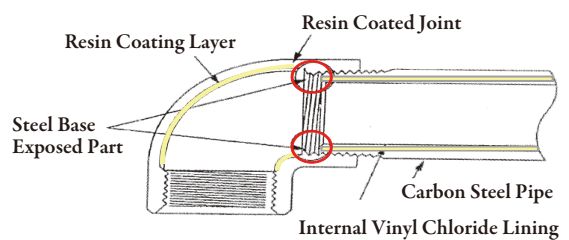
Red rust spreads from the red circled positions.

① Rust at the Joint ② Rust spread between Vinyl Coated Layer and Bare Metal  
What happened to those two kinds of rust 5 years from installation is shown below.

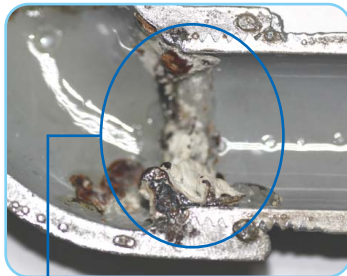
Calcium Layer and Black Rust at the Joint

Bare metal exposed section developed white calcium under which solid black rust was formed. It should be noted that not only black rust but also calcium layer is formed on top. You may recall calcium corrosion control method. By installing THE BIOWATER, one can expect the corrosion control effect by black rust and calcium at the same time.

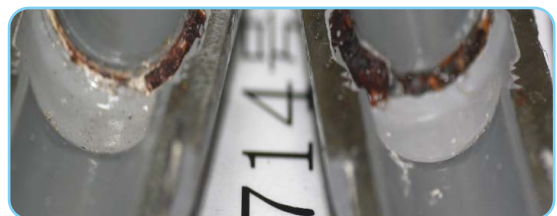
Furthermore, after removing calcium layer the black rust underneath is formed as if it were artificially welded to surround the bare metal portion.

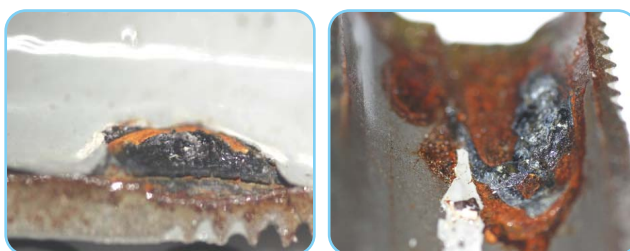
② Rust spread between Vinyl Coated Layer and Bare Metal

Water penetrating to the gap between vinyl coated layer and bare metal caused degradation of the pipe. We came across cases like this occasionally and in all such circumstances they turned to be black rust, putting a halt to the degradation as shown in these photos.

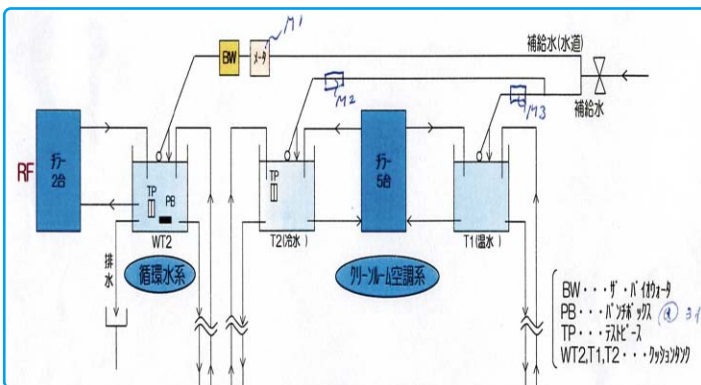
Test Overview: We processed the water in cushion tank (WT) in the circulatory water system by THE BIOWATER. We compared the result with that of unprocessed control tank (T2) of the clean room ventilation system. We put test piece in each tank for comparison.

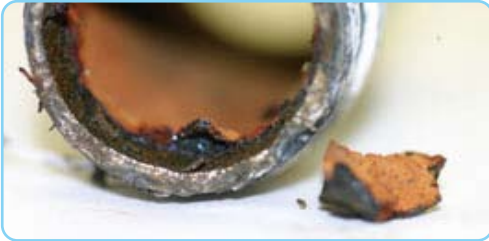
Pipe wall has black rust after installing BW

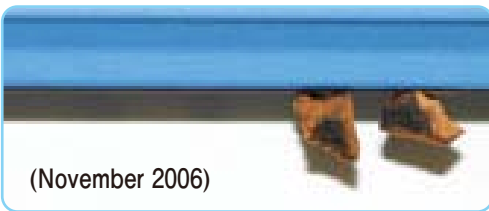
(November 2006)

Black substance sticks to magnet bar proving the matter is black rust or magnetite.

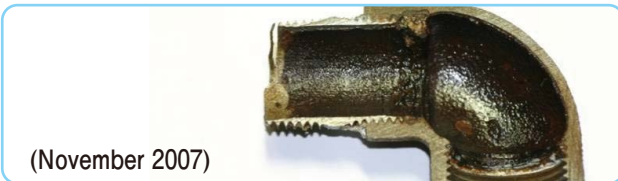
(November 2007)

THE BIOWATER was installed in 1997. After 10 years of use, the pipe was removed. As the picture shows an exquisite layer of black rust overspread the entire inner wall of the GP pipe. This protective shield put an end to the degradation of the pipe, never causing leakage.

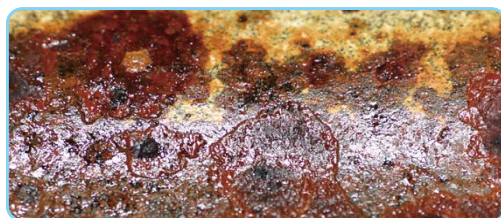
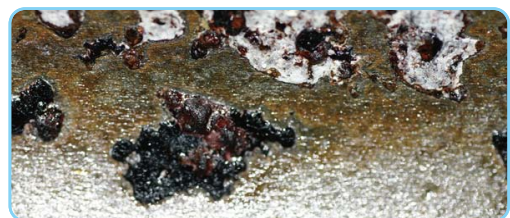
Calcium Covering underneath Iron Rust Layer    Rust Layer Bottom and Bare Metal

After four (4) years from installing THE BIOWATER, we observed the pipe and found calcium covering underneath iron rust layer as we can see from the photograph in the center. We conducted acid cleansing and eliminated the red rust. We now observed black rust clusters that put an lid to the holes of the bare metal as seen in the photograph on the right.

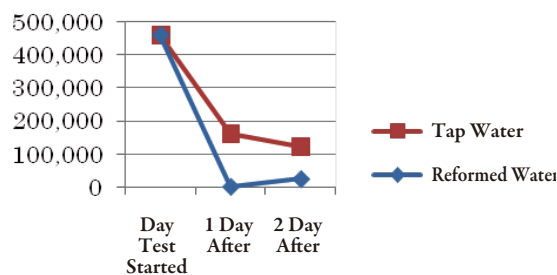
○Changes of Legionella Bacteria Counts

Test Progress
Legionella ATCC#33153	Date of Start: No difference Reformed water: Rapidly reduced on Day 1. Reduced to 5% of the start on Day 2. Tap Water: Reduced to 35% on Day 1. Reduced to 26% on Day 2.
Observation	Reformed water is showing 5 times antibacterial power of tap water.
O-157 ATCC#335150	Date of Start: Reformed water showed immediate reduction by 6%. Reformed Water: 17% increase on Day 1. 47% decrease from previous day on Day 2. Tap Water: 4% increase on Day 1. 120% increase from previous day on Day 2.
Observation	Reformed water shows approximately 4 times antibacterial power of tap water.

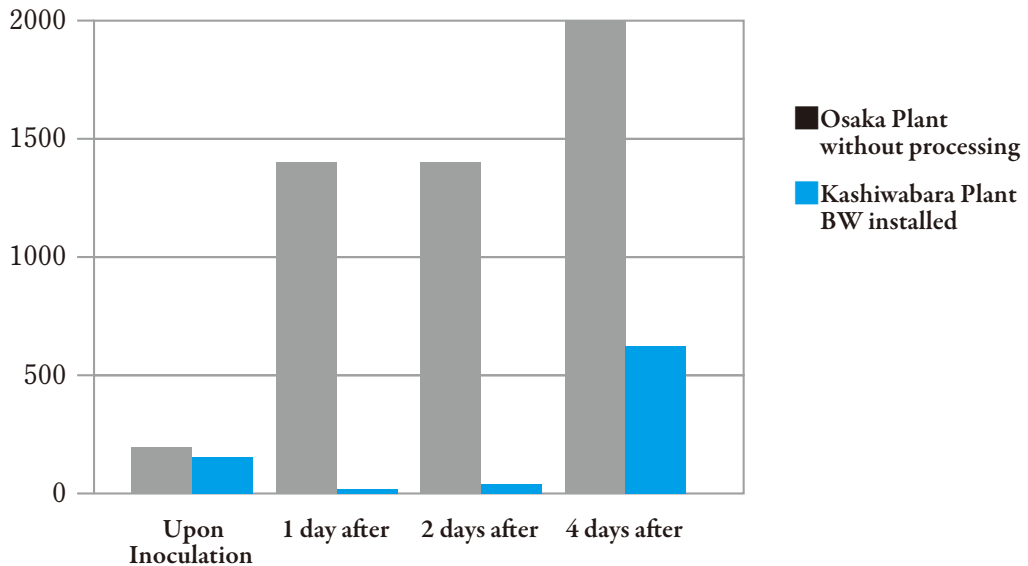
## Comparison of Plant Data caused by THE BIOWATER

Upon inoculation	1 day after	2 days after	4 days after
Osaka Plant Ice Plant Water 36°C	196	1400	1400	2000
Kashiwabara Ice Plant Water 36°C	155	21	41	624

(Unit: CFU/ml)

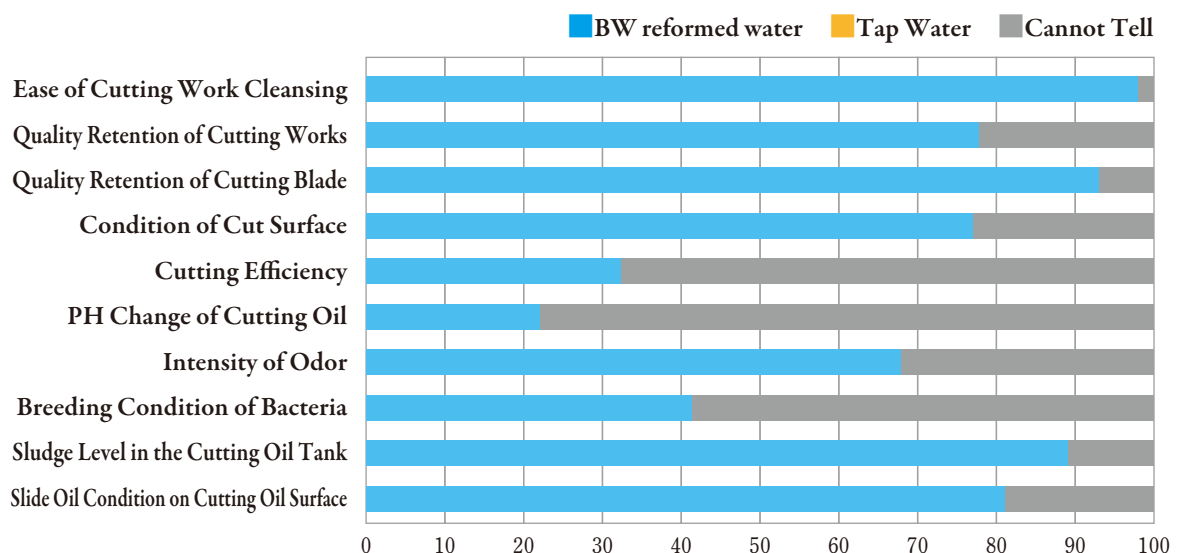
### Change of Cutting Process depending on the Water Quality of Soluble Cutting Oil

Checked Item	BW is better.	Not Sure	Tap Water is better.
Stains around Machinery	80.9%	19.1%	0%
Slide Oil Condition on Cutting Oil Surface	89%	11%	0%
Sludge Level in the Cutting Oil Tank	41.3%	58.7%	0%
Breeding Condition of Bacteria	67.7%	32.3%	0%
Intensity of Odor	45.4%	54.6%	0%
PH Change of Cutting Oil [agent degradation& useful life]	22%	78%	0%
Change of Cutting Efficiency	32.4%	67.6%	0%
Condition of Cut Surface	76.8%	22.2%	0%
Quality Retention of Cutting Blade	93%	7%	0%
Quality Retention of Cutting Work [rust after 3 weeks]	77.8%	23.2%	0%
Ease of Cleansing Cutting Works	98%	2%	0%

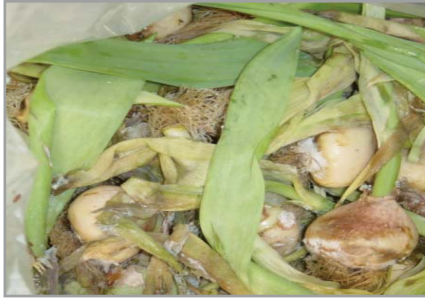
Tulip Bulb for Hydroponic Culture

Disposal Loss Rate of 13% Up to Now

13% was broken down to 1 to 2% at purchase, 3% from fungi during preservation, 3% from sprouting or rooting defects, and 3% from budding.

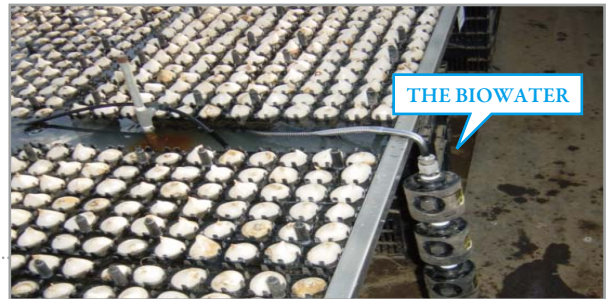
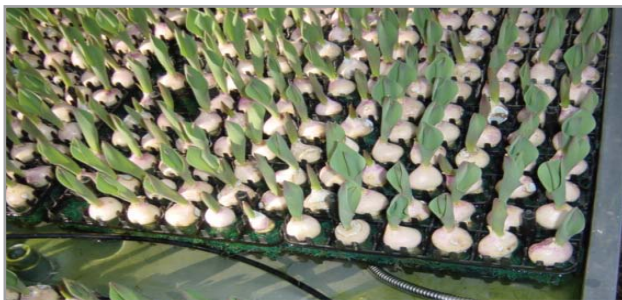
All the bulbs sprouted, which had never happened before.

They grew steadily and they achieved nearly 100% yield.

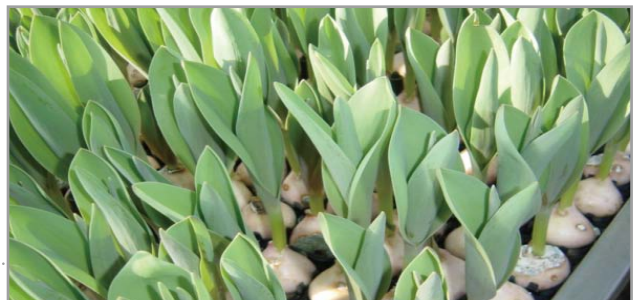
Furthermore, fungi attached to the bulb disappeared entirely! [The object looking like scab in the photograph is dead fungus, which naturally peel off the bulb by shipment.]

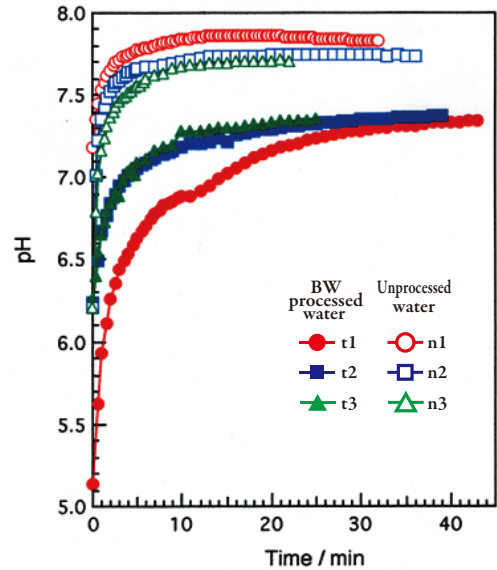
On the other hand, in the case of cold or hot water reformed by THE BIOWATER, the dissolved gas is not vaporized. Instead, the gas is either incorporated in the sequence of water molecules ( clathrate hydrate) or preserved in stable condition among the similarly sized particles of water molecules. This is clear in that the normal "alkali shift" seen in ordinary water is restricted in the case of THE BIOWATER reformed water as shown in the right-hand chart.

Time change of pH for processed and unprocessed water  
t1~t3 processed water at different times  
n1~n3 for unprocessed water

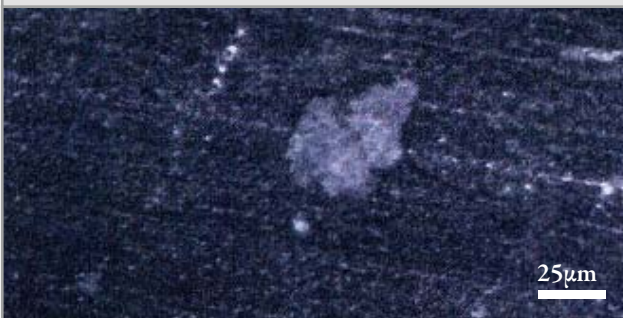
#### Case of Unreformed Water

#### Gelled Deposit Layer

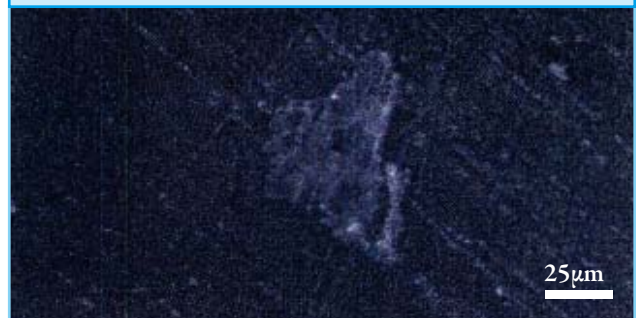
#### Case of BW Reformed Water

#### It is flat and gelled coating is sporadic

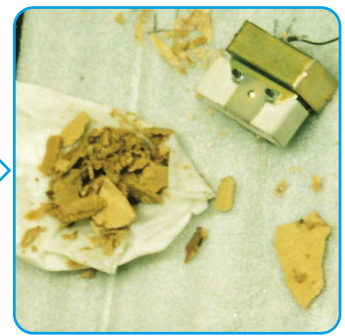
Scale from Within

June 29, 1997  
[Two Weeks after Installation]  
Scale has been peeled off.

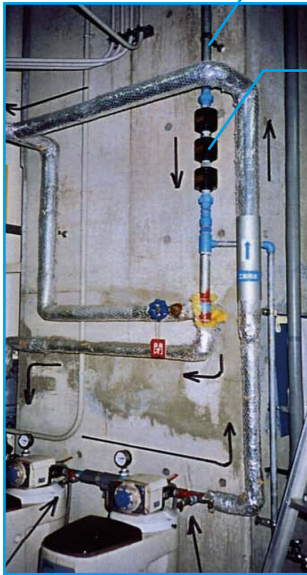
Observed from inspection opening of the boiler.

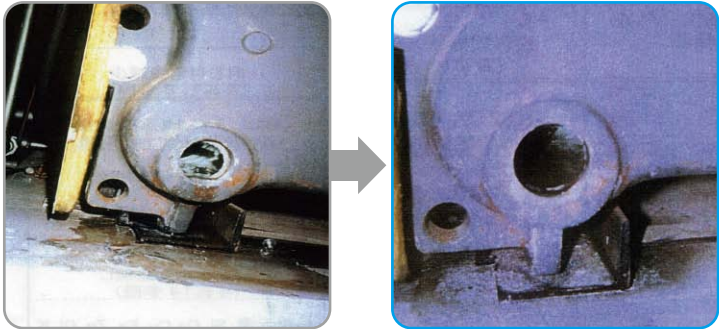
July 15, 2000  
We can see scale deposition.

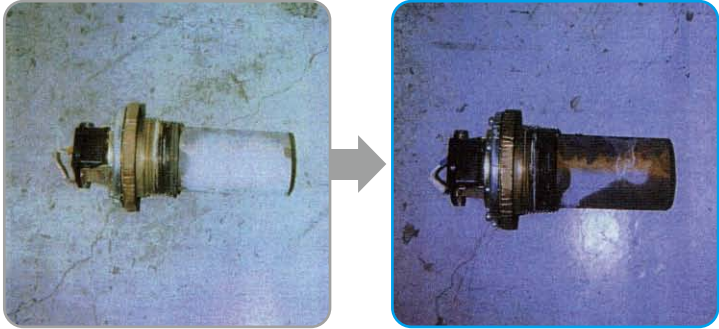
### Scale Attachment Situation on Low Water Level Boiler Shutoff Equipment

September 15, 2000  
Scale is attached.

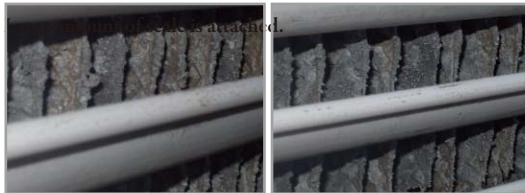
Cooling Tower 1 (with no BW processing)

## Test Results:

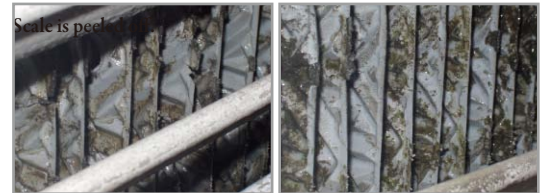
Cooling Tower 2 (with BW & Punchbox Immersion)

Test Method: We installed THE BIOWATER and two sheets of Punchbox (PB hereafter) to one of the two cooling towers of identical conditions.

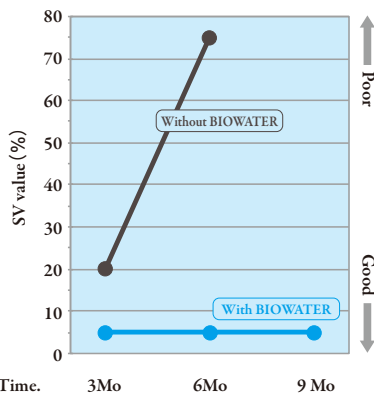
Time Change of SV Value

Time.	3Mo	6Mo	9 Mo
With BW	5	5	5
Without BW	20	75	70

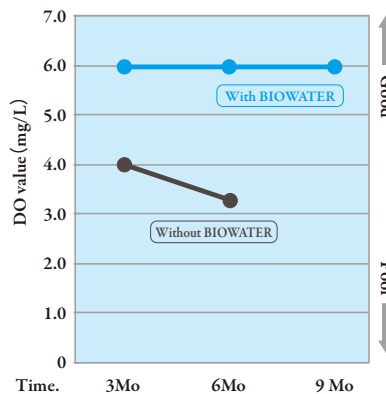
Time Change of DO Value

Time.	3Mo	6Mo	9 Mo
With BW	6.0	6.0	6.0
Without BW	4.0	3.3	4.0

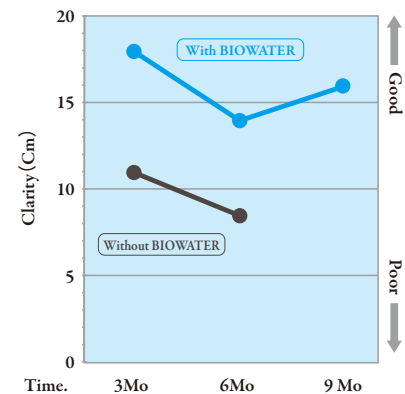
Time Change of Clarity

Time.	3Mo	6Mo	9 Mo
With BW	18.0	14.0	16.0
Without BW	11.0	8.5	11.0

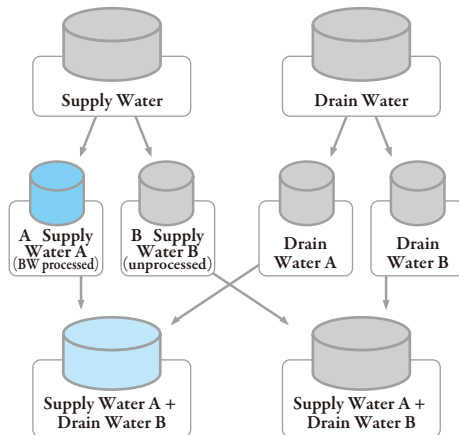
### 1. BOD Laboratory Test Method

- ① Feed-water and sewer water was sampled for one liter each at Maruzen K.K. Saitama plant.
- ② We halved feed-water into two 500ml parts, calling them A and B. The same was done for sewer water. Then we reformed feed-water A by THE BIOWATER.
- ③ We mixed feed-water A and sewer-water A. We also mixed feed- water B and sewer water B. Mix ratio is one to one because of 500ml each.

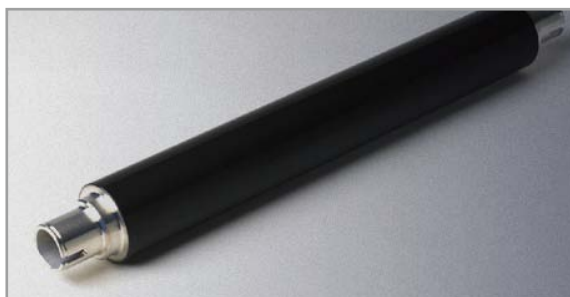
[Heat Roll]

Heat roll is considered the heart of office machines like copiers. This is because heat roll needs to be perfectly circle so that the printed surface will not have thick and thin ink spots. For this to be ascertained, all the heat rolls are checked before completion and delivery. At times, hand polishing is done. Yield of this product has been increasing 1% per year but it stopped at 95%. So they started to reform the water and the yield of 100% was constantly achieved.

A device to fix toner to the memory media by heat and pressure for copier and printer.

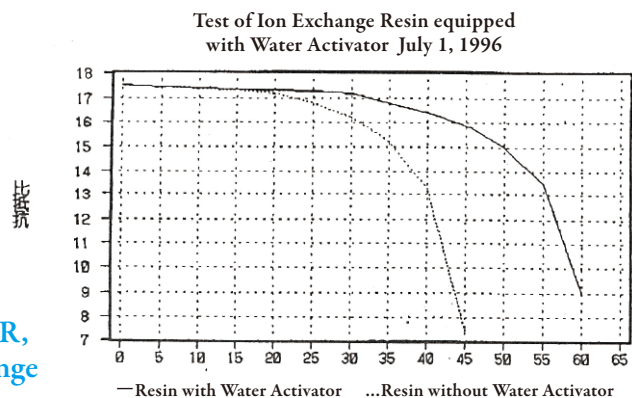
**Test Conditions:** ① Ion Exchange Resin: C-40S, containing 40 liter of resin volume, made by Nippon Rensui Co.  
② Water Activator: THE BIOWATER 1-2-3, ceramic water activator, made by Toshi Kogyo Co., Ltd.  
③ Measuring Instrument: KD-32 made by Kurita Water Industries Ltd.  
④ Test Period: April 4, 1996 through June 22, 1996

When we installed THE BIOWATER, life extension effect to the ion exchange resin was a longer life of 38%.

[Note 1] Normally, useful life of ion exchange resin is tested by molybdc acid method measuring silica volume in the water in circulation. The volume of silica is judged by the strength of fluorescent color which is caused by the reaction of molybdc acid and silica. In this test, the total volume of silica remained unchanged before and after flowing through THE BIOWATER. However, nearly 20 % of silica did not react to molybdc acid. This is because 20% of silica was clathrated or hydrated and did not bind with molybdc acid. It is because the creation of silica coating which reduces the life of ion exchange resin was restrained due to the reformed water. Control of scale creation resulted in longer life for the ion exchange resin.

Useful life of ion exchange resin with THE BIOWATER was 62 days whereas that without BW was 45 days. **In the case of installing THE BIOWATER, operating life of ion exchange resin was extended by approximately 38%. See the chart.**

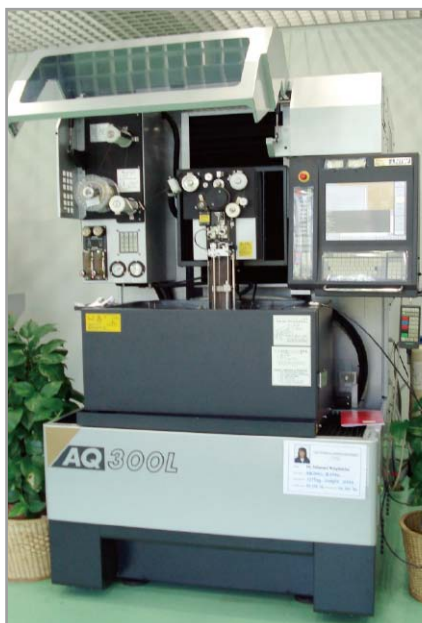
Test Method: We used BW device to reform the tap water to be used for processing liquid of 40 liters. We provided additional supply of BW reformed water when the processing liquid was not full. We compared the useful life of ion exchange resin when we used BW reformed water with the case when we did not.

① Before using BW reformed water, the useful life of ion exchange resin was 1400 hours, while after using BW reformed water, it became 2924 hours, **approximately doubling** the ion exchange capability.
